Rio Tinto

28 July 2011

Subject: UPDES Permit UT000051, Notification of tailings slurry release to surface

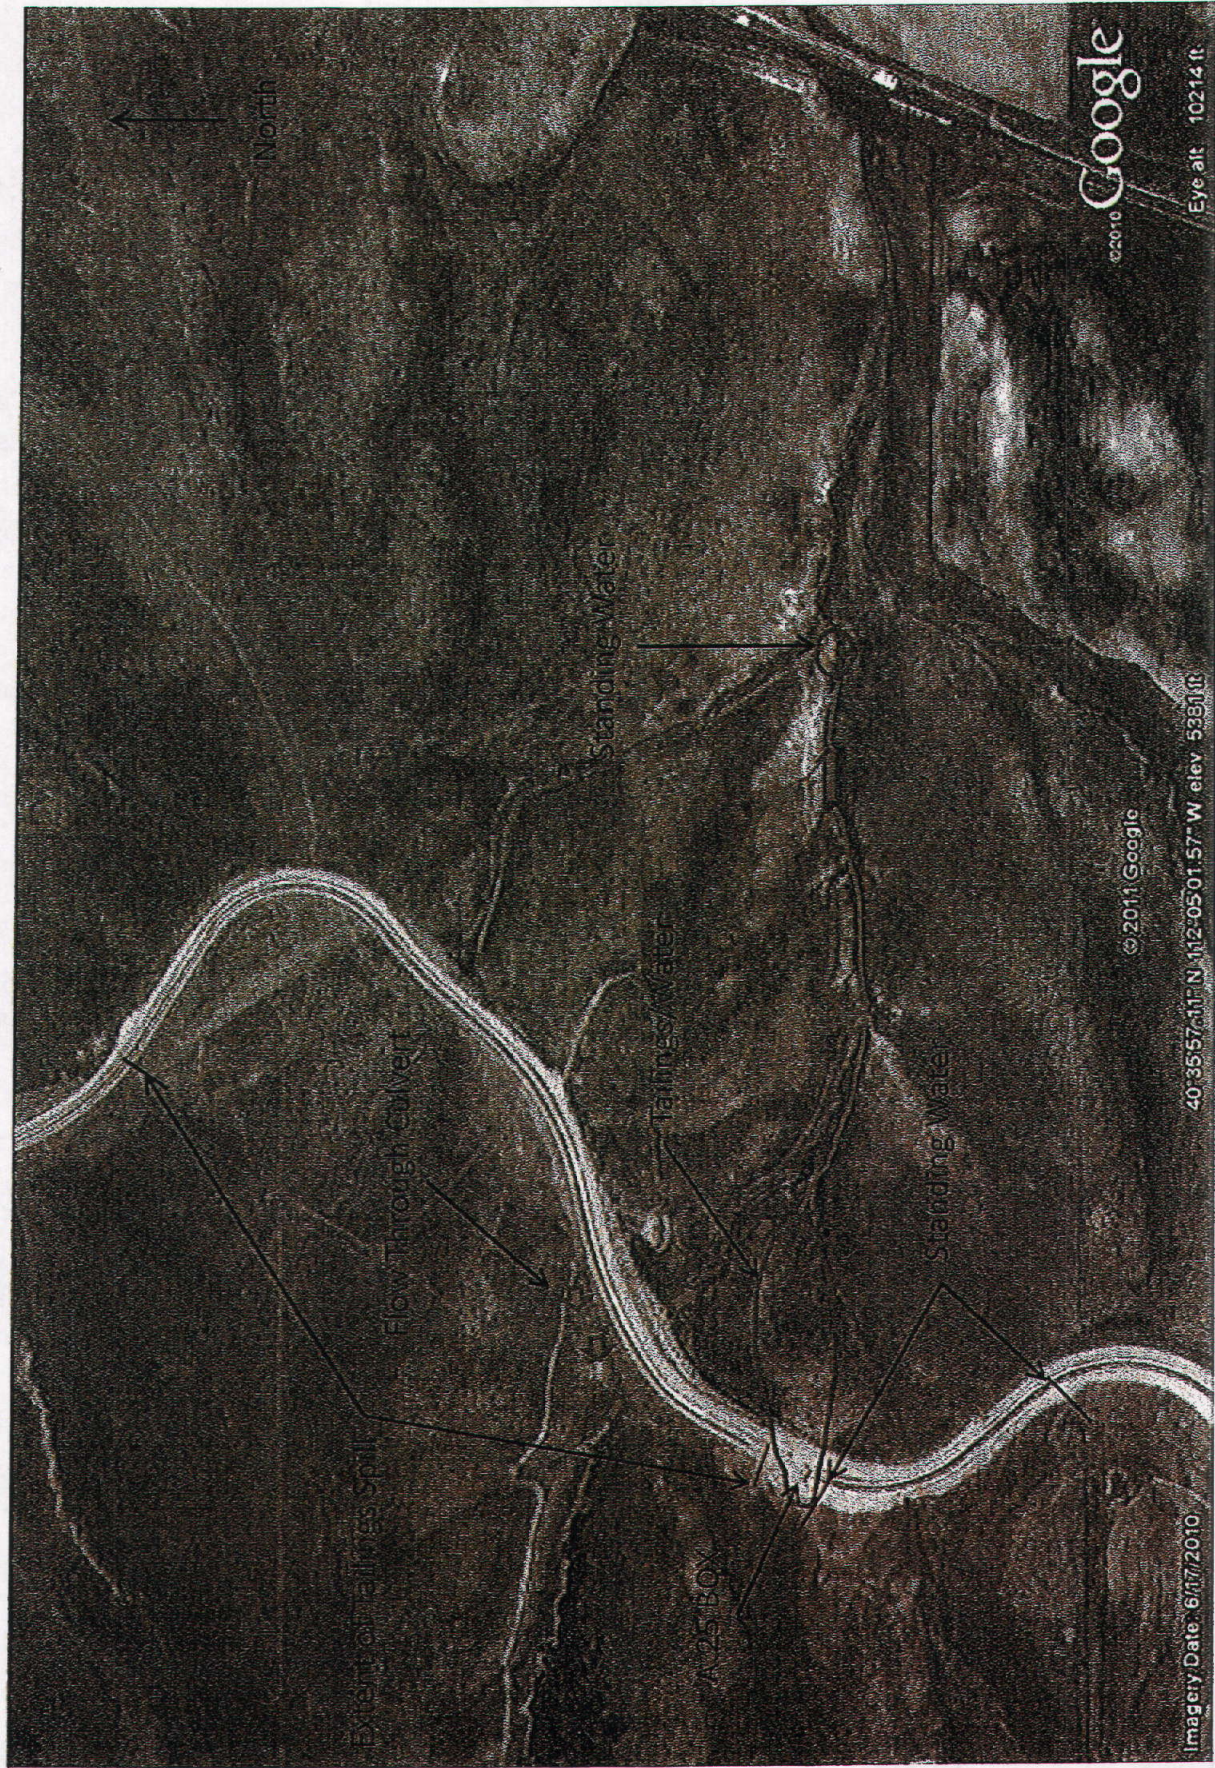
Tailings A.25 BOX Spill

The release occurred at a point designated Drop Box A.25, which is located approximately miles 1800 feet north of Barney's Canyon creek. The release began at approximately 12:20 pm and lasted approximately 80 minutes. The circumstances leading to the release are under review by Kennecott. It appears that the release occurred while the Concentrator lost overflow pumping capability while draining the #3 tailings thickener. The flow overwhelmed the tailings 60-inch pipeline and tailings were discharged from the drop box and a number of inspection covers and vent risers. KUC calculates that approximately 337,680 gallons of slurry was released. Calculations for the entire release were based on the current operating flow in the tailings pipeline, plus the additional water from various sources, and the loss of operation of the Concentrators seven overflow pumps.

The tailings release impacted several areas, as shown on the attached figure, including:

- South of Drop Box A.25 approximately 600 feet; water was confined between the tailings 60-inch and 48-inch pipelines. The water was tested for pH in the field which turned out to be approximately 5.5 to 6.0.
- North of Drop Box approximately 0.7 miles, the material was confined to the road located on the left side of the 60-inch pipeline (looking north). The average depth the material (solid) was approximately 1 to 4 inches.
- East of the tailings line the slurry flowed the tailings line road and onto natural vegetation where the majority of the coarser material settled out before finding an ephemeral wash where it was confined, and finally stopped approximately 0.5 miles from the source of the release.

Much of the water portion of the slurry infiltrated or evaporated soon after the release. Kennecott installed a portable pump into a pool of water just south of drop box A.25 approximately seven hours after the release began and recovered approximately 27,000 gallons of water. KUC has attempted to mobilize equipment to remove remnant tailings from the roadway and the area between the tailings pipelines, but tailings are too liquid to remove as of the date of this report. KUC will remove tailings from these areas as soon as they are workable. KUC does not intend to remove tailings from the natural areas or the ephemeral wash because removal will create a much greater impact than leaving the benign tailings in place.
